Bats in churches: balancing conservation needs

Church bat roosts can be a contentious issue, even occasionally surfacing in Parliamentary questions. With professional interests in conserving both churches and bats, Nicholas Kelly provides a personal perspective

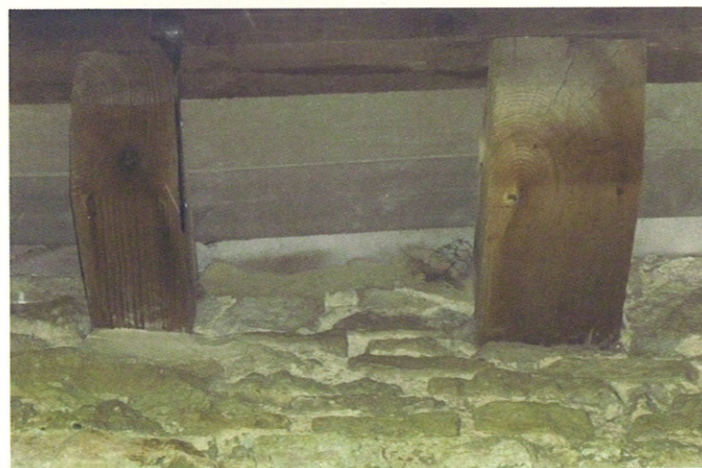
Image 2 – An illegal partial obstruction of a roost entrance following building works. The fur-oil stain to the soffit board indicates a bat roost entry point, obstructed by recently applied mortar

The cultural heritage of churches is managed by the respective Diocesan Authority through Faculty approvals, largely mirroring the Listed Building regime, protecting against inappropriate alterations, additions or removals affecting the fabric or furniture. Equally protected under the Conservation of Habitats and Species Regulations 2010 as part of our designated Natural Heritage, it is illegal to disturb, capture, injure or kill a bat, or to damage, destroy or obstruct a bat roost (see Image 2).

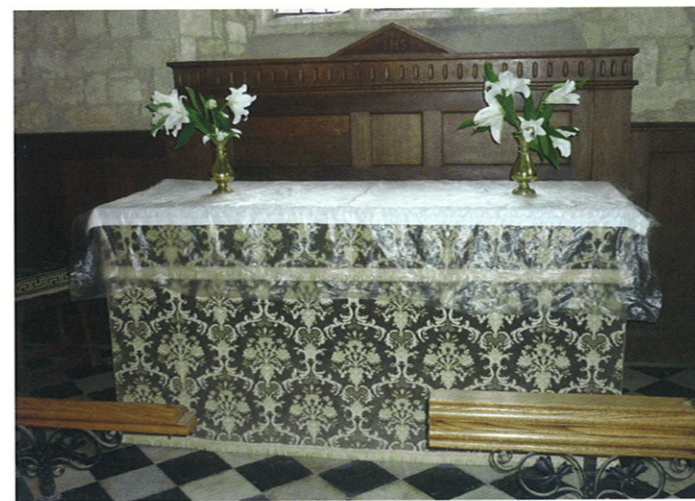
Image 3 – Plastic sheet protective covers. These are simple and easy to install and remove

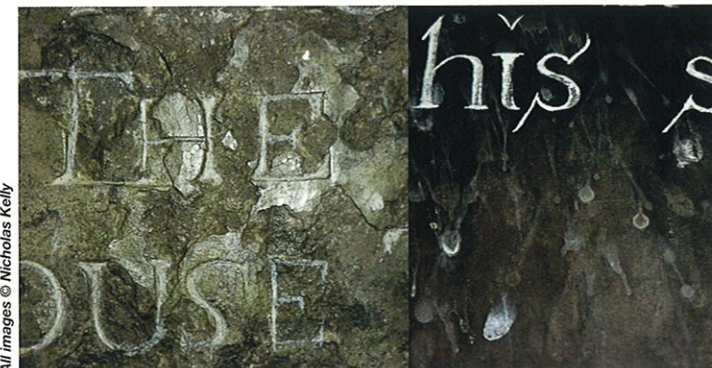
Image 1 – Difficulties in damage apportionment. Similarly dated wall plaques within the same major bat roost exhibiting dramatically differing damage: (left) the lower plaque within reach for cleaning is delaminating, (right) the upper plaque merely shows spotting

cleaning methods and materials, inherent material defects or the variable environmental conditions (temperature, relative humidity and light), though some damage clearly results from bat waste (see Image 1).
